international magazine of oral implantology

Resorption mechanism of an injectable calcium phosphate bone regeneration cement – Radiographic and histological monitoring

author_ Sérgio Alexandre Gehrke, Brazil

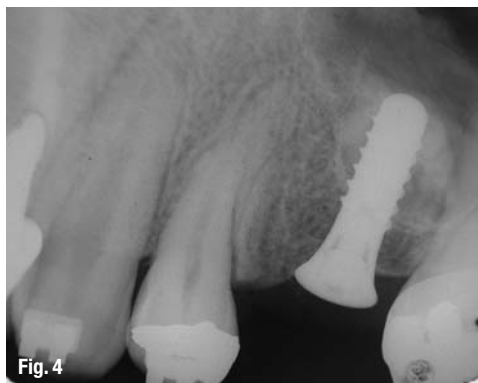
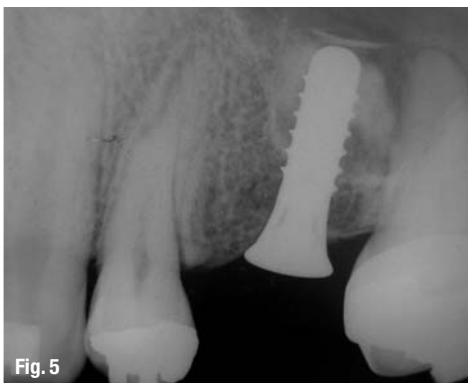
Fig. 4–7_ Radiographs of case I at 30, 60, 120 and 180 days after surgery.

Thanks to the adequate radiopacity of the cement, it is easy to perform a radiographic follow-up and analysis of the resorption and new bone growth. Radiographs were therefore taken at 30, 60, 120 and 180 days after implant installation (figs. 4–7), as well as 12 months (fig. 8) after installation of the restora-

talOs cement. This process progresses towards the center of the cement mass. In the sinus lift case, the progress also takes place from the coronal towards the apical region around the implant (yellow arrows on figure 4). Across the different times of analysis it is possible to see that the material is gradually being replaced and the osseous tissue is being formed, apparently without incorporation of cement particles. At the end of the neoformation process, the newly formed bone displays radiographic characteristics which are similar to those of the native surrounding bone. This is also confirmed after 12 months of loading, where the bone around the implant has not resorbed, indicating a good preservation of the new osseous volume around the implant.

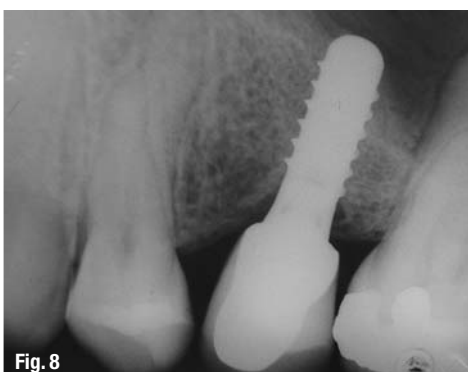
Fig. 8_ Radiograph of case I taken 12 months after loading.

Fig. 9_ Pre-operative radiograph (case II).

Fig. 10, 11_ Implant installation and filling with PD VitalOs Cement.

The second case is a 40-year old female patient in good health condition, non-smoking, presenting with a fracture of tooth 14 and presence of a large radicular cyst (fig. 9) requiring removal of the root. The site presented a very large loss of bony structure, with fenestration of the buccal side of the socket wall. Therefore, the implant could only be stabilized in the inferior wall of the sinus cavity with the use of Summers' osteotomes.
