Buccal dehiscence and sinus lift cases

Predictable bone augmentation with synthetic bone material

Authors_ Dr Sérgio Alexandre Gehrke, Brazil & Dr. Giuseppe Maria Famà¹, Italy

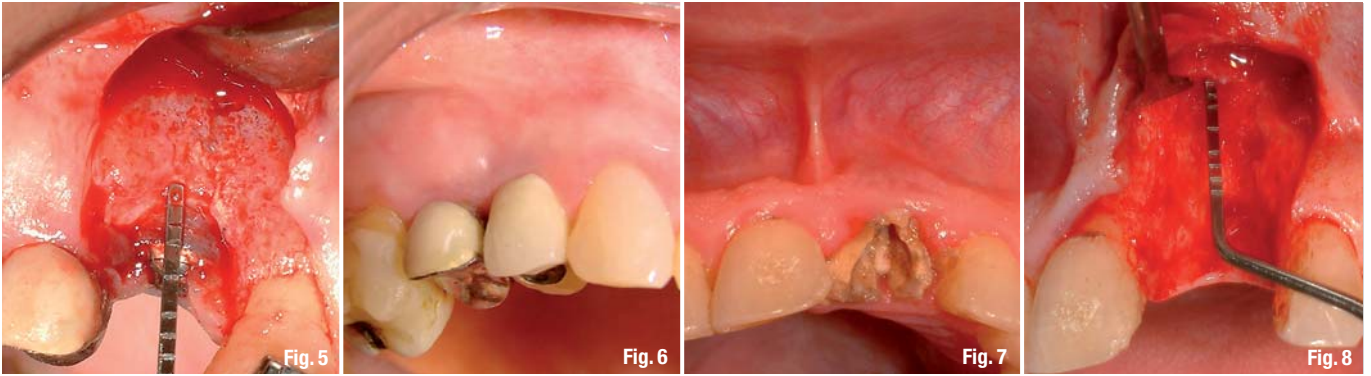
ograph as well as clinically (Fig. 1). The facts that the fracture was old and that a fistula developed around the root resulted in a large loss of the buccal bone wall. The treatment options were presented to the patient, who signed an informed consent form. The patient presented no contra-indications to the treatment.

markings (Figs. 2 & 8). The implants placed were in each case a Straumann RN SP (4.1 mm diameter, 14 mm length). The implants were installed at the level of the crestal bone of the adjacent teeth.

The injection of VitalOs must always be preceded by adequate control of the bleeding with the suction canula. The cement is placed within the defect without need for over-filling (Figs. 3 & 9), unlike what is often done with other types of bone substitutes like granules. Any material put in excess is always expelled or resorbed. With VitalOs, as the cement forms a block, a large quantity or even the whole material may be expelled. When the injected quantity is in large excess, the hardened block can easily break up and large pieces may be expelled out of the site. With granular materials it is only small granules that are expelled and this is less disturbing than pieces of cement. This is the reason why we never overfill sites with VitalOs.

A suture is then made with a 5-0 nylon suturing material. No attempt is made to achieve primary suture over the implant (Figs. 4 & 10) because we observed that even when the cement remains exposed to the oral environment, the bacteriae cannot adhere onto the surface of VitalOs and therefore no infection develops. The implants with a large platform help to maintain the volume and anatomy of the gums because they act as a shape keeper for the gingiva. A post-operative radiograph is taken for each case 7 days after implantation.

The sites were re-opened three months after implant installation to install the healing abutments. Measurement of the buccal bone level was measured again with the periodontal probe (Figs. 5 & 11).

After gingival conditioning, impressions were taken and the prosthetic restorations were made according to manufacturer's (Straumann) instructions. The two cases were followed up after one year and the esthetic result can be seen on Figures 6 and 12. The results show that there was neither loss of tissue nor gingival retraction in the grafted areas. Therefore, the anatomy obtained after implantation was maintained one year after restoration, ensuring a stable esthetic result.

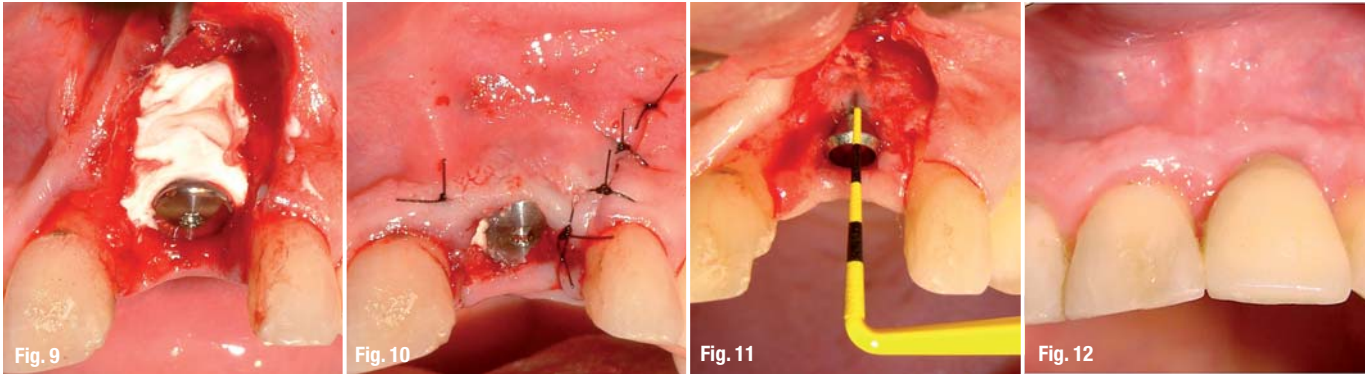
Case 2 was a 54-year old non-smoking male patient in good health with no contra-indication to the proposed treatment, who presented with a maxillary right central incisor following a root fracture as can be seen on the pre-operative radiograph and clinically (Fig. 7). Given the radiographic and clinical findings it seemed evident that the buccal bone wall was resorbed. The treatment options were presented to the patient, who signed an informed consent form.

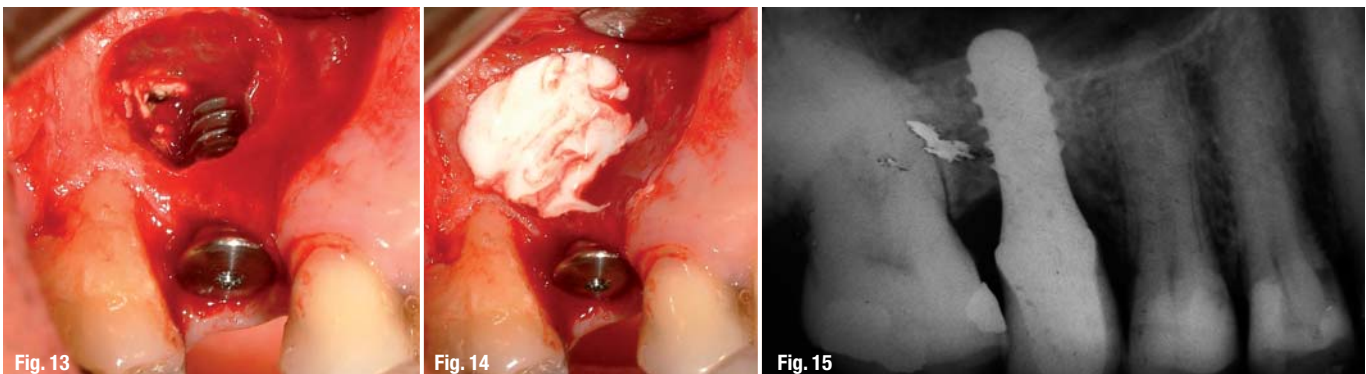
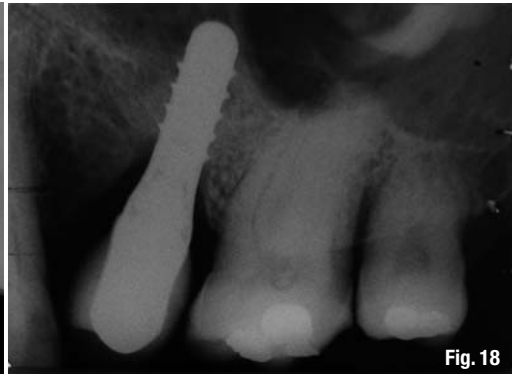
After local administration of anesthetics (Scandicaine 2%, Septodont) an intrasulcular incision was performed around the root and a lateral incision was made on the buccal side to gain access to the lateral wall of the maxillary sinus. After creation of the lateral window, the sinus membrane was carefully lifted and the site was prepared for implant installation. Then, the cement was injected against the inner (nasal) sinus cavity up to half of its width, and the implant Straumann RN SP (4.1 mm diameter, 12 mm length) was then installed (Fig. 13). Once the implant installed, the rest of the sinus cavity was filled with the cement (Figs. 14 & 16). The suture was made with 5-0 nylon simple

stitches. A post-operative radiograph was taken 7 days after surgery (Fig. 17). The distance between the sinus floor and the implant apex was measured on the radiograph. The results are shown in Table 2. The patients were recalled after one year to take a radiograph of the treated sites (Figs. 15 & 18).

We already observed that the process of resorption of the cement coupled with new bone growth can be conveniently followed up radiographically (Gehrke 2009). One year after functional restoration we could see that the level of newly formed bone was maintained, without loss around the apical portion of the implants. This is a very positive finding because the loss of bone at the apical level after loading the implants is a common phenomenon when this type of sinus grafting is performed.
